Project: [Project]
Regarding: **Site Progress/Quality Control – Security System Review**
Site Date: [Date]
Document Date: [Date]
Prepared by: **Jim Adams**

Site Progress/Quality Control SPQC Summary

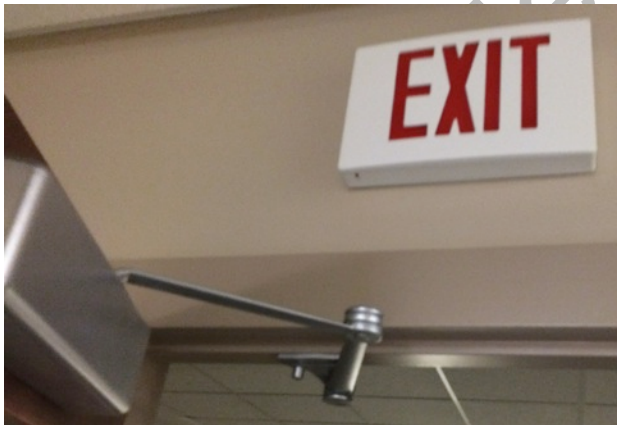
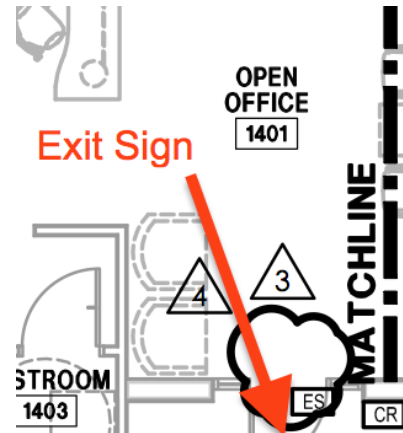
4. Exit sign above door 1400 entering Room 1401 Open Office is missing its directional chevron that would direct one to the right. As it is installed, the exit sign implies going through an access controlled door with the wrong swing (note door below exit sign)

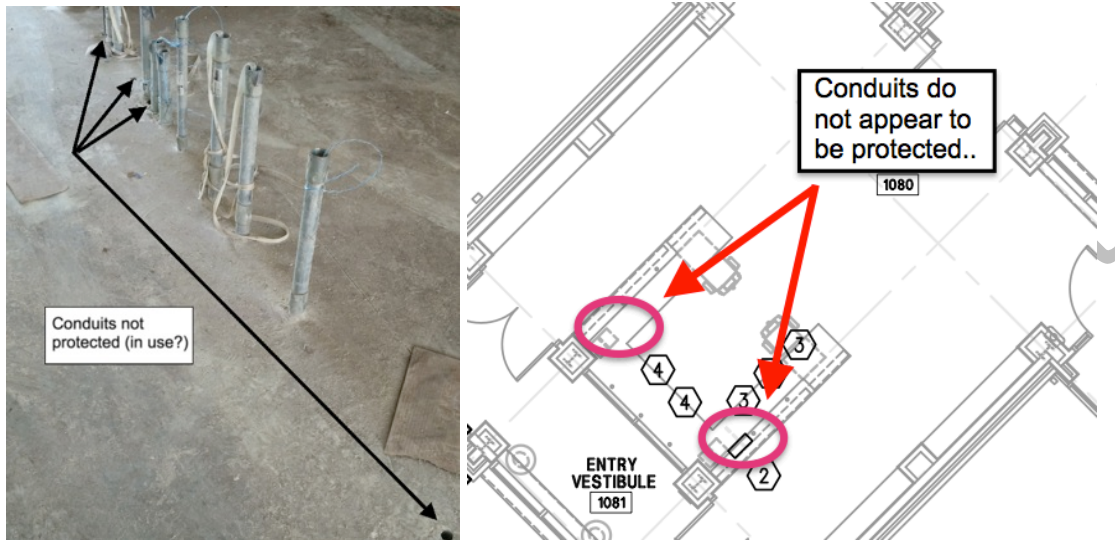
7. Conduits openings that are flush with floor in floor do not appear to be protected from debris in Room XXXX Entry Vestibule. Are they abandoned?
